Changes in land cover in coastal erosion hotspots in the southern Caribbean of Costa Rica during the period 2005-2017

Luis Sandoval-Murillo¹ • Gustavo Barrantes-Castillo¹

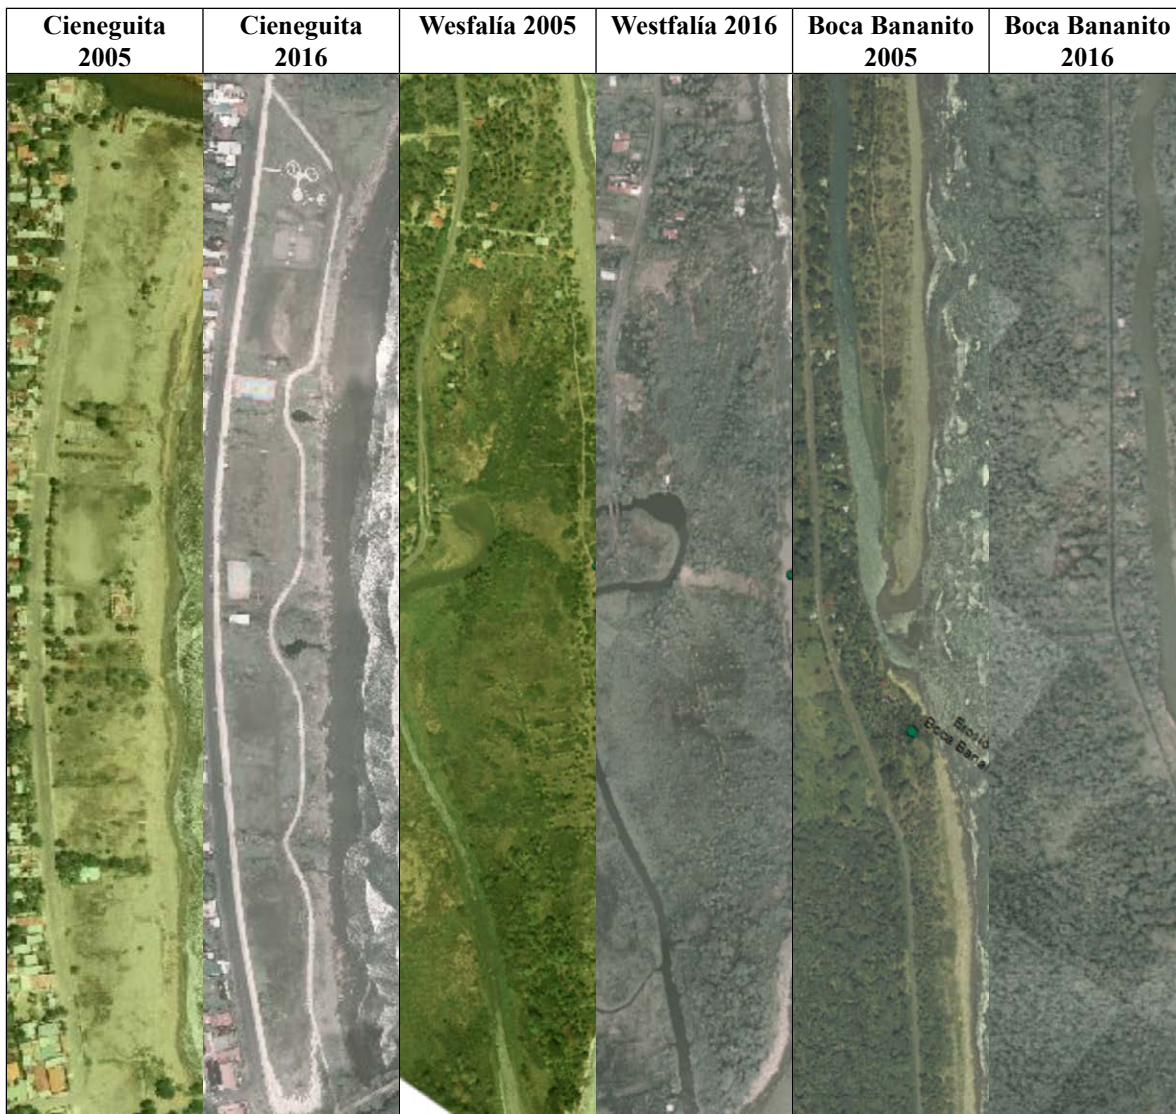
Figure 5. Changes in land cover according to aerial photography 2005 - 2016.

Made from a mosaic of orthophotos from 2005 at a scale of 1: 5 000, with a spatial resolution of 0.5 meters (from the National Registry), 2) Orthophotos from 2016 at 1: 1 000 scale, with a spatial resolution of 0.1 m (property of the National Emergency Commission (CNE)).

land and beaches decreased in area as the area covered by sea increased (Figure 6). However, beaches also decreased in area as a result of increases in the coastal vegetation that grows on the sandy bar north of the river mouth (Figure 5).
